WATER DAMAGE INVESTIGATION

**Department of Developmental Services
340 Main Street
Worcester, Massachusetts**

Prepared by:
Massachusetts Department of Public Health
Bureau of Environmental Health
Indoor Air Quality Program
December 2018

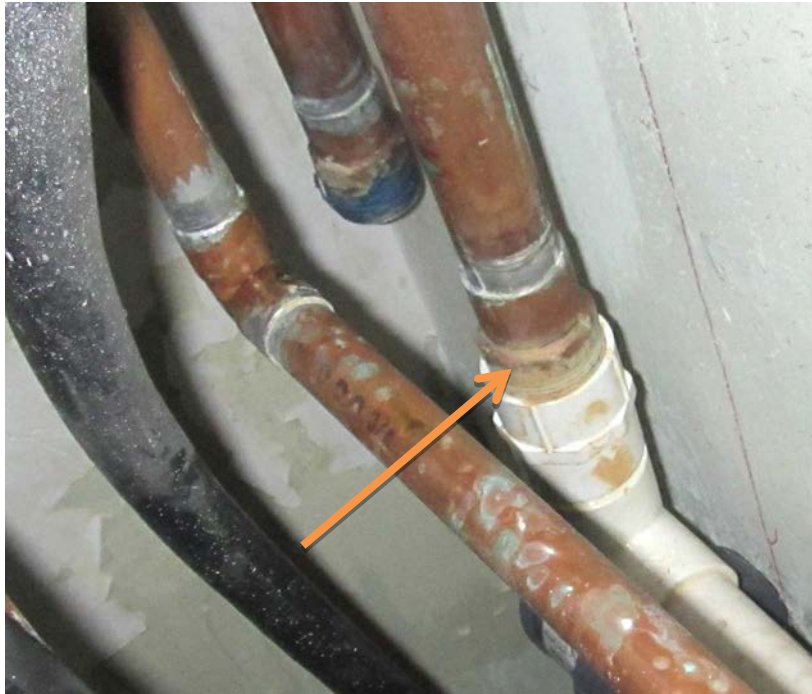
Picture 1

Cooling line joint with PVC was origination of water leak

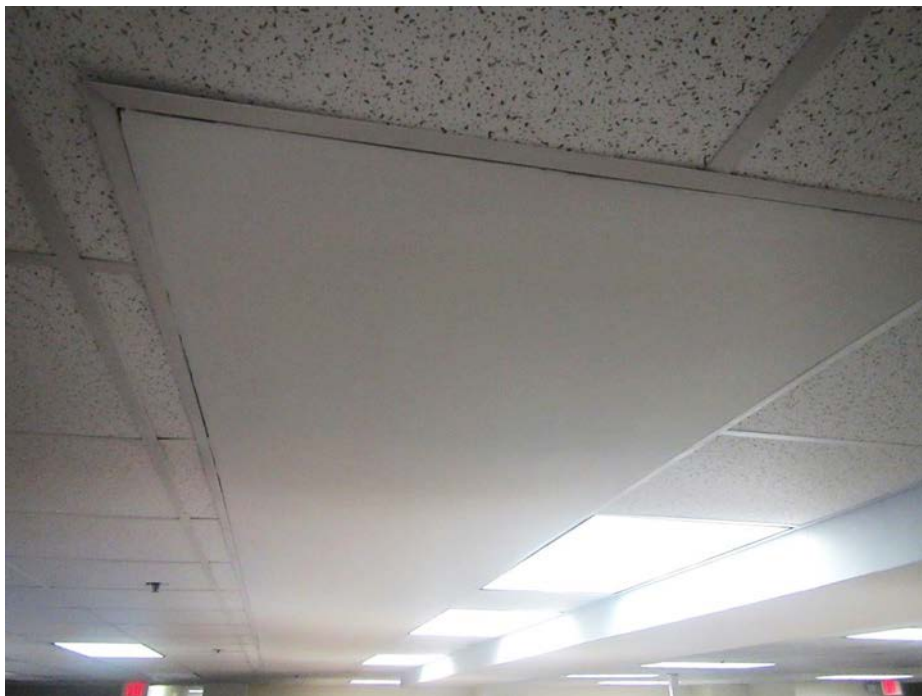
Picture 2

Area of water-damaged ceiling tiles that were replaced

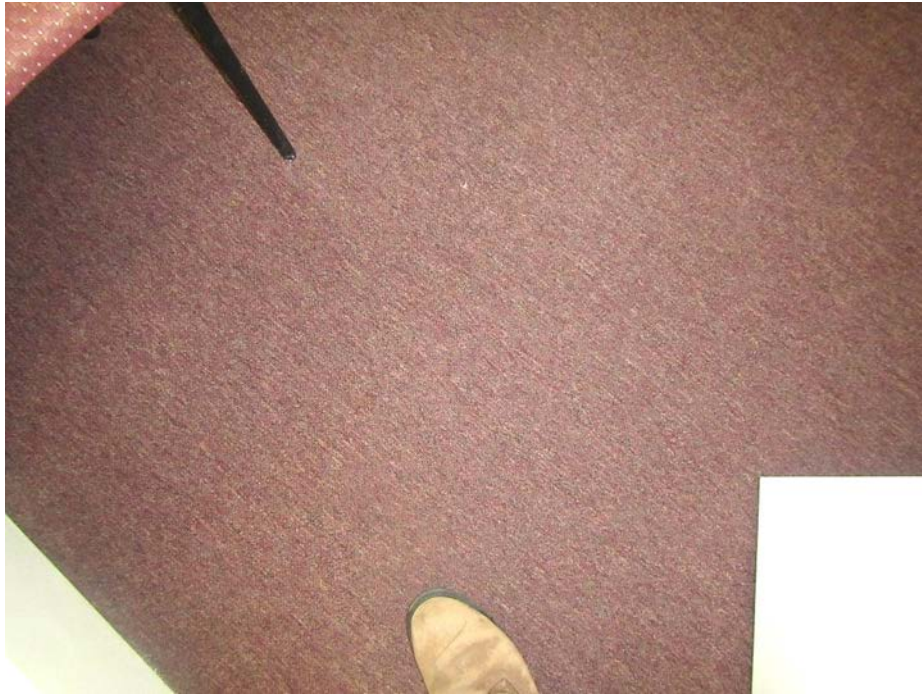
Picture 3

Area of water-damaged carpet tiles that were remediated

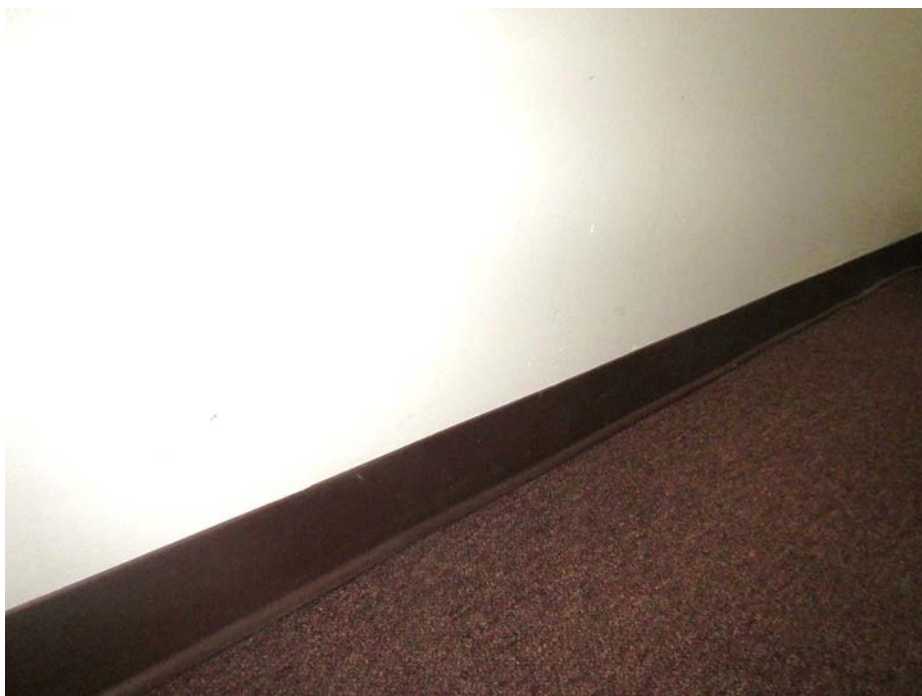
Picture 4

Water-damaged office with vinyl baseboard that was left in place

3. Inspect areas behind vinyl coving for any microbial contamination in offices #50 and #54 since this material typically hinders adequate drying following water damage events especially during humid weather. Remove and replace coving/lower portion of GW if necessary.
4. Clean carpeting in accordance with IICRC recommendations (IICRC, 2012).
5. Operate HVAC system/set thermostat to fan “on” (continuous) mode vs “auto” to facilitate air exchange.
6. For more information on mold refer to the US EPA’s “Mold Remediation in Schools and Commercial Buildings”. Available at: <http://www.epa.gov/mold/mold-remediation-schools-and-commercial-buildings-guide>.
7. Refer to resource manuals and other related IAQ documents for further building-wide evaluations and advice on maintaining public buildings. Copies of these materials are located on the MDPH’s website: <http://mass.gov/dph/iaq>.

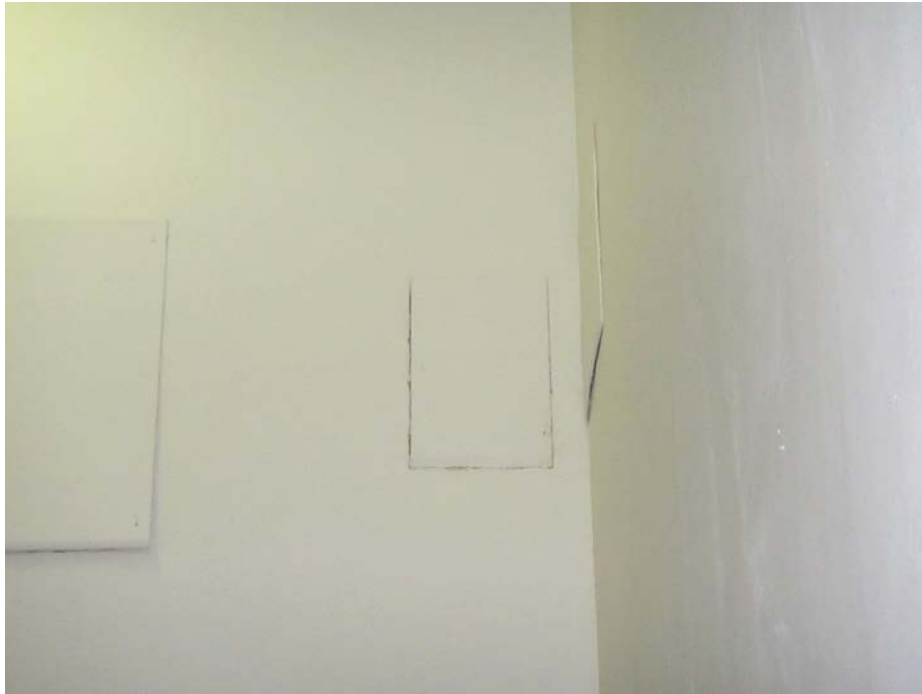
Picture 5

Building management also reported that the hot water line in the rear stairwell had a slow leak prior to its discovery. Fortunately, the building materials in the stairwell (Picture 5) consist of materials which are not typically conducive to mold growth (e.g., plaster, concrete). Dust and debris on these materials can however serve as a medium for colonization if chronically moistened. Water extraction, fans, and dehumidifiers were also used in this leak incident. Some occupants expressed complaints regarding odors emanating from the stairwell during the remediation for this incident.

Site of 2nd leak in stairwell; note plaster walls

2. Seal any pathways between this space and the stairwell where the chronic water leak occurred (e.g., install tight fitting door strip/gasket; seal any holes in walls or above ceiling tiles leading to the stairwell).
